REPORT NO. 710/78

PHOTOGRAPHIC STUDY OF IMPACT  
OF BALL AND ARMOR PIERCING AMMUNITION  
ON ARMOR PLATE

E. L. Reed  
Research Metallurgist

December 21, 1936  
WATERTOWN ARSENAL  
WATERTOWN, MASS.

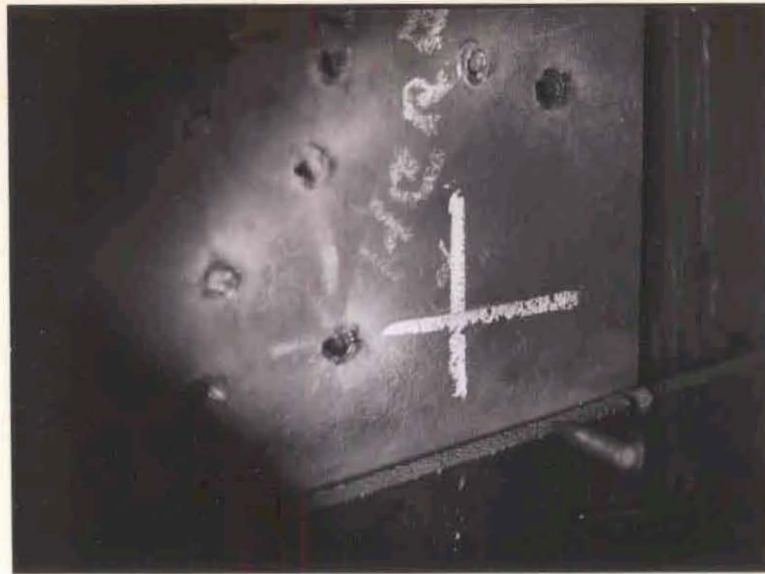
Figure 5 - Photograph by reflected light of  
Cal. .30 Armor Piercing Service Velocity  
bullet in flight (striking distance  
100 yards)

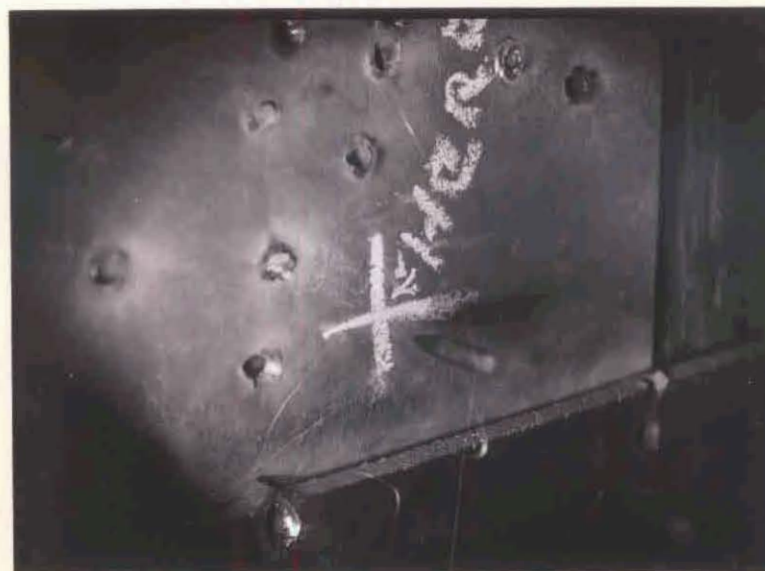
Figure 6 - Photograph by reflected light of  
Cal. .30 Armor Piercing Service  
Velocity bullet in flight just about to  
strike Armor Plate. Striking distance  
100 yards.

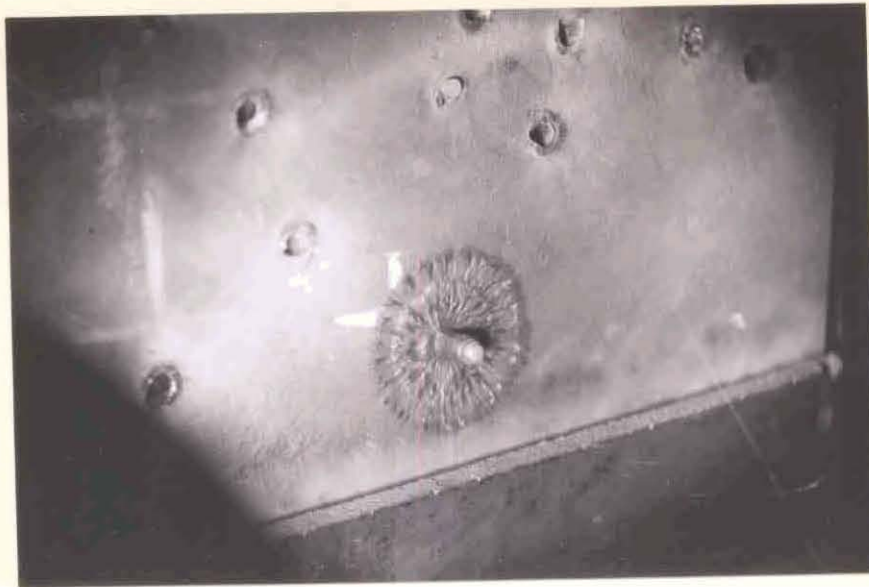
Figure 9 - Photograph by reflected light of Caliber .30 Armor Piercing serviced velocity bullet in progress of penetration of Armor Plate. (striking distance - 100 yards.)

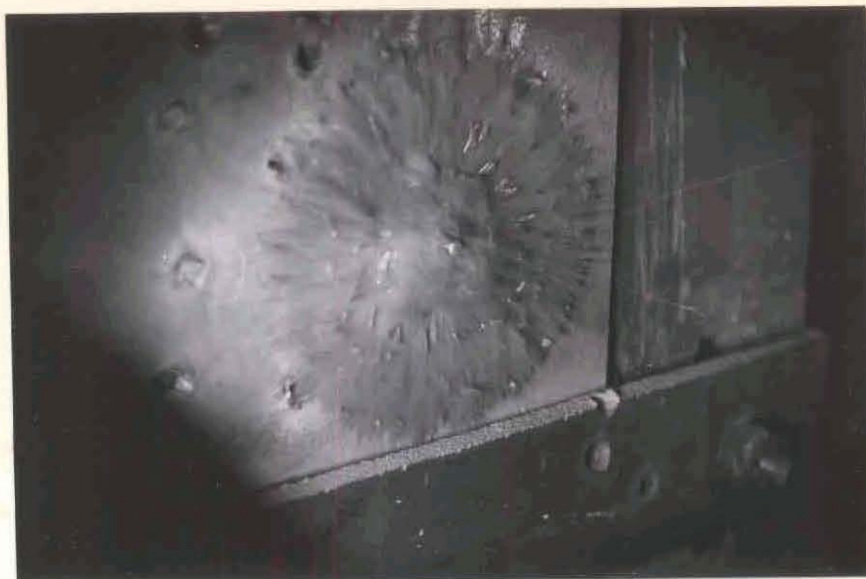
Figure 11 - Photograph by reflected light of Caliber .30 Armor Piercing service velocity bullet in progress of penetrating Armor Plate. (Striking distance - 100 yards.)

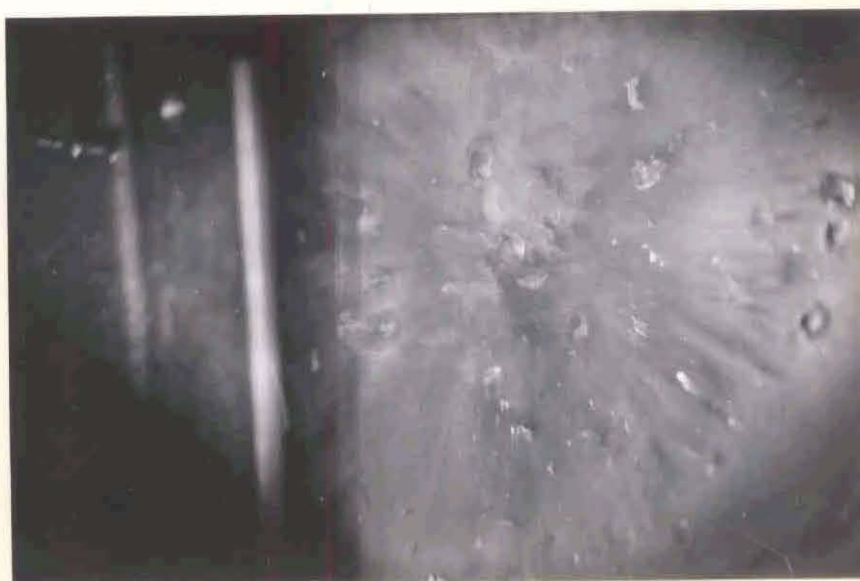
Figures 5, 6, 7, 8, 9, 10, 11 and 12, show an interesting series of photographs of Cal. .30 Armor Piercing service velocity bullet in various stages of impact on heat treated homogeneous one half inch Armor plate at a distance of one-hundred yards. The approach of the bullet to plate is shown in Figures 5 and 6. At the immediate moment of contact of bullet on plate, flares probably of incandescent lead particles are evident, see Figure 7. On further penetration of plate the jacket metal apparently peels off and is thrust forward on plate, see Figures 8 and 9. Later stages of impact of the bullet are illustrated in Figures 10, 11 and 12 in which particles of jacket metal and lead splash are blown from the area of impact. Unfortunately the actual penetration of the plate is masked by flying particles during the impact.

Figure 12 - Photograph by reflected light of Caliber .30 Armor Piercing service velocity bullet in progress of penetrating Armor Plate. (striking distance - 100 yards).

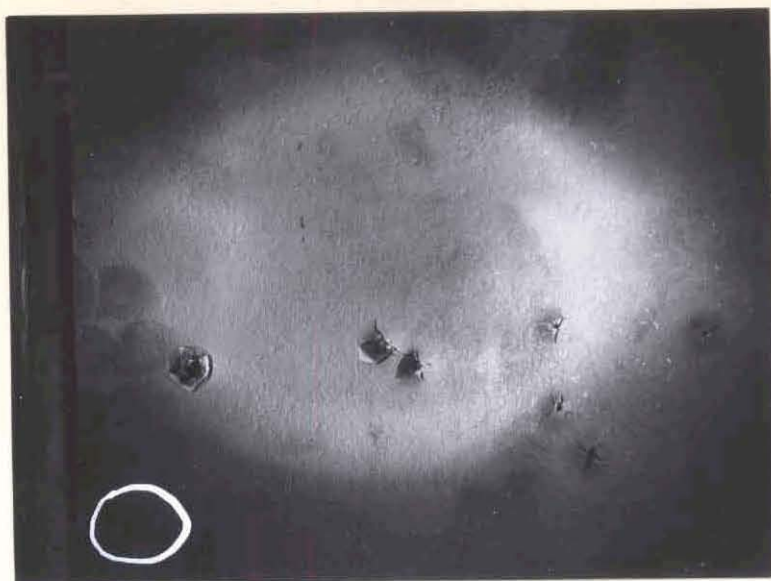
Figure 13 - Back face before impact

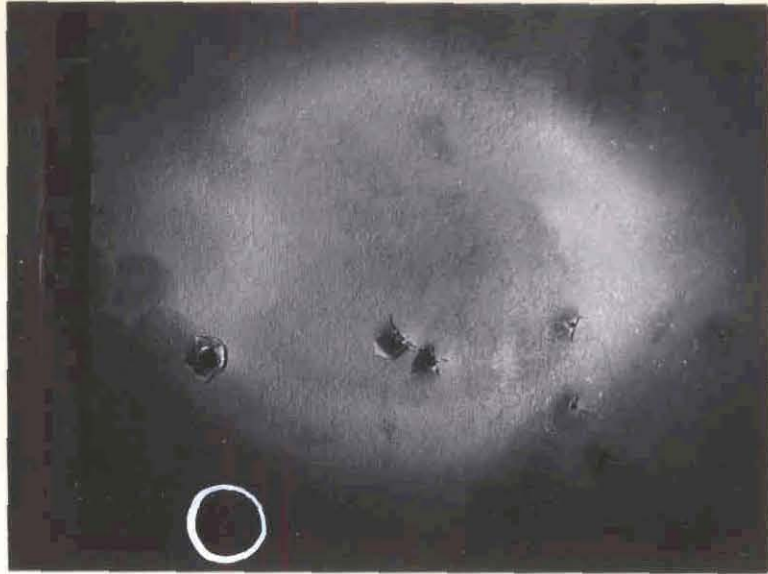
Fig. 15 - Back face after impact. Photographs taken by reflected light. Ammunition - Caliber .30 Armor Piercing service velocity at a distance of 100 yards.

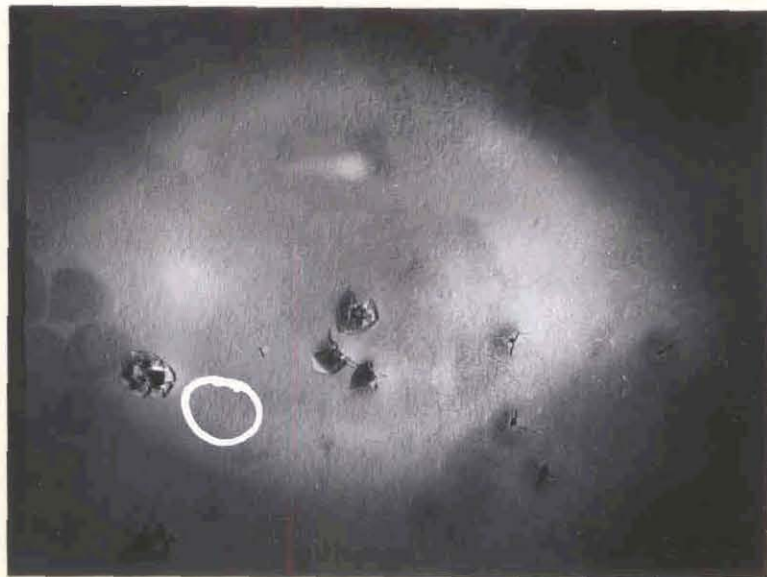
Figure 16 - Back face before impact.

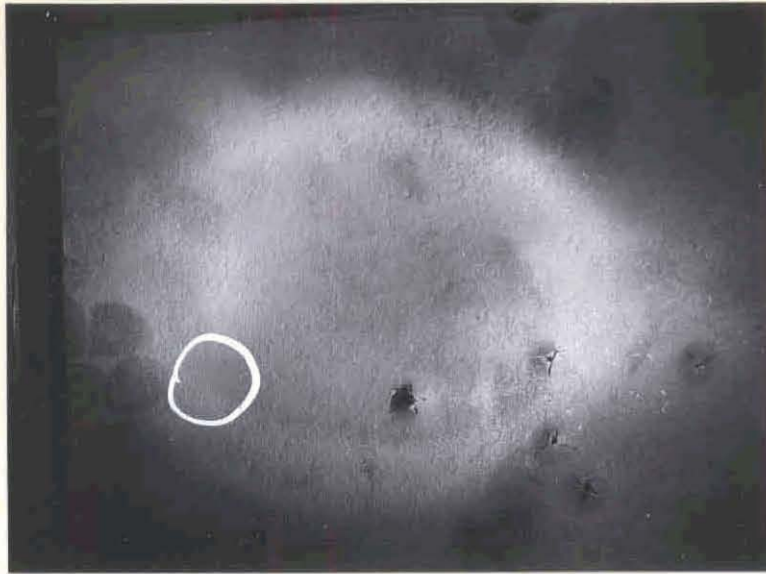
Figure 19 - Back face before impact.
